Potential traces of earthquakes in the ancient city of Kytaiia, Kerch Peninsula, Crimea[☆]

E.A. Molev^{a,*}, A.M. Korzhenkov^b, A.N. Ovsyuchenko^b, A.S. Larkov^b

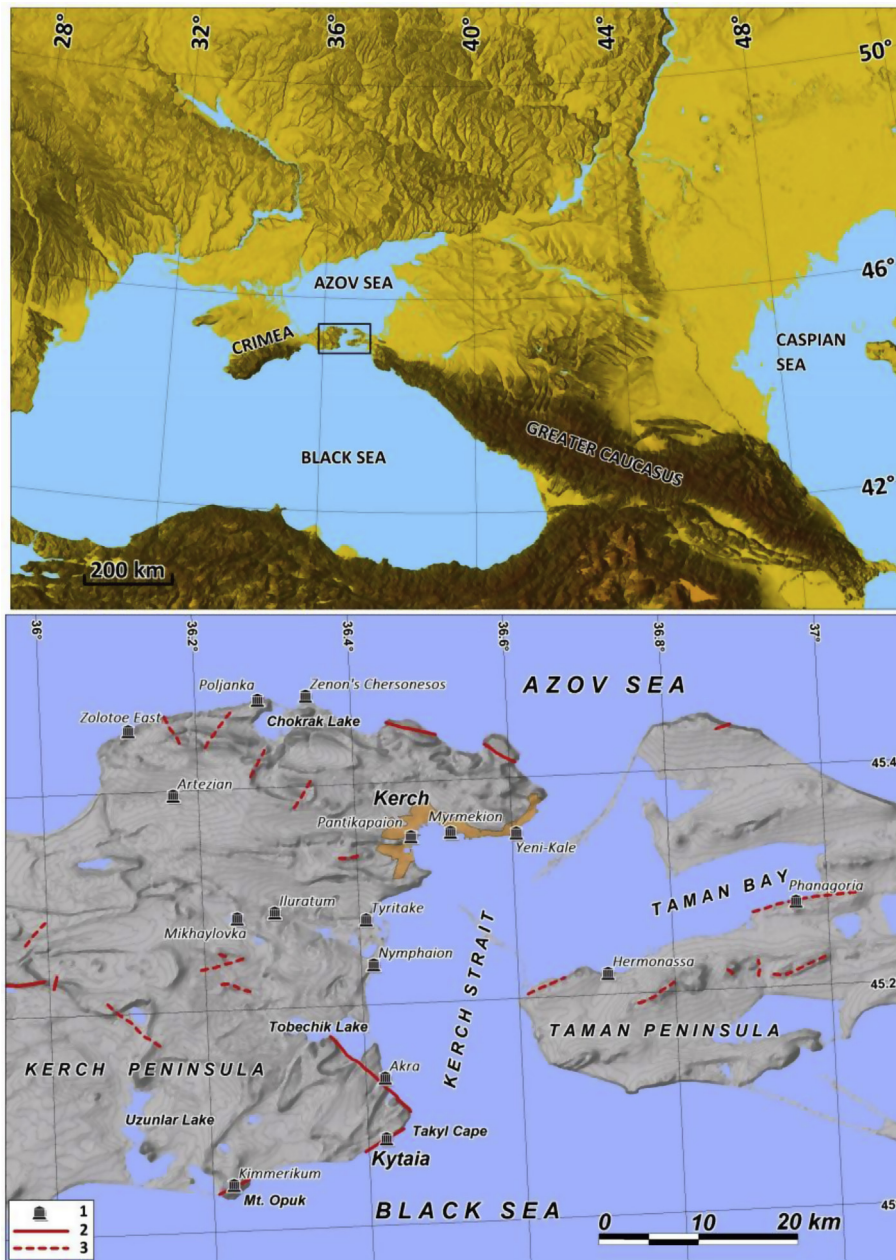
Fig. 1. An overview map of the study area (top) and the map of ancient cities and active faults in the Kerch-Taman area (bottom), showing information as follows: 1 – archaeological monuments with the evidence of earthquake activity; 2 – active faults with the traces of seismotectonic movements; and 3 – active faults inferred from the structural and geomorphological data, active faults of the mud volcano type, and flexural fault deformations of Late Pleistocene and Holocene deposits and landforms.

The ancient town of Kytaiia is located on the southern shore of the Kerch Peninsula, Crimea (see Fig. 1). Based on modern instrumental seismic data, seismic activity at the Kerch Peninsula is relatively low today [20,21]. However, there are quite many traces caused by relatively strong earthquakes that took place in the region in the ancient time. This is supported by both written sources (Dio., Cass. XXXVII, 11,4; Oros., VI, 5, 1) and modern archaeo- and paleoseismic studies [22–34]. For example, one of the strongest earthquakes described by the aforesaid ancient authors occurred in 63 BC. Blavatsky [1977] studied its traces in the Panticapaeum city [35].

Opuk. According to the researchers who studied these deformations [26], they seem to be seismotectonic by origin, i.e. they were caused by the surface rupture(s) of a strong earthquake. Similar deformations are observed in abrasion-exposed Neogene-Quaternary deposits on the Black Sea coast, up to the Kytaiia city. It appears that the archaeological site under discussion is located closely to a major seismogenic structure (see Fig. 1).

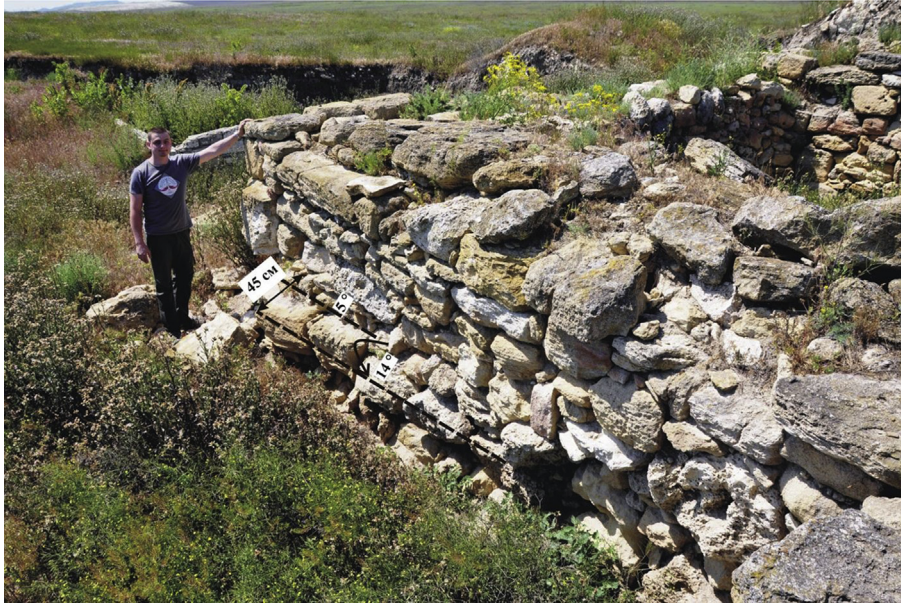
Fig. 2. An on-site photo showing the location of the SSW-trending wall.

A SSW-trending wall (with a 148° azimuth) is tilted at about 45°, with stone rows displaced up to 20 cm to the east (in a row-by-row manner), which is located in the *western part of excavation site I* west of the SW tower (see Fig. 2).

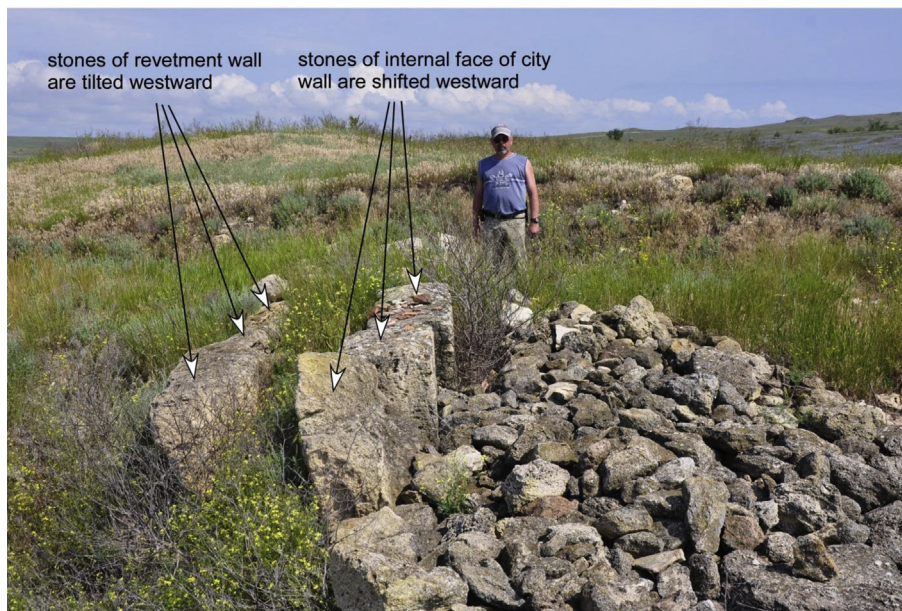
Fig. 3. The on-site photo of the stones of revetment wall and the stones of internal face of city wall, showing the main trend of the wall and the rotation angle of the southern block.

Three adjacent blocks rotated systematically counterclockwise were identified in the eastern face of the eastern city wall (*northern part of the excavation site IV*). The main trend of the wall is 160° and the rotation angle of the southern block is up to 8° (Fig. 3). The wall is dated to the late 4th century BC.

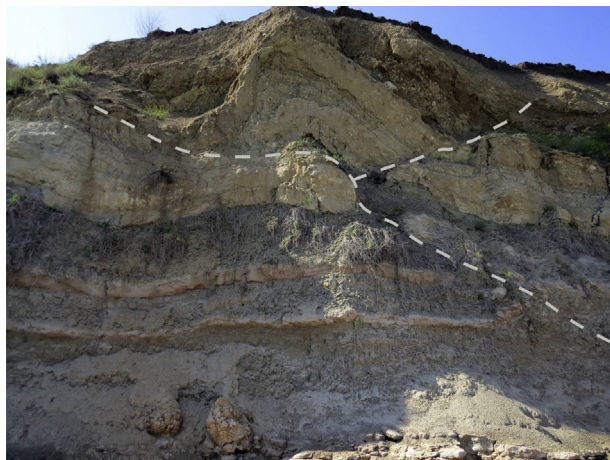
Fig. 6. The on-site photo of the near-thrust anticline southwest of Kytaia.

similar structure (Fig. 6). Between the thrusts, at the top of the major anticline, the loess deposits overlie, without any apparent break, laminated lacustrine-marine clays with shell fragments that are dated roughly to the Late (or Middle) Pleistocene.

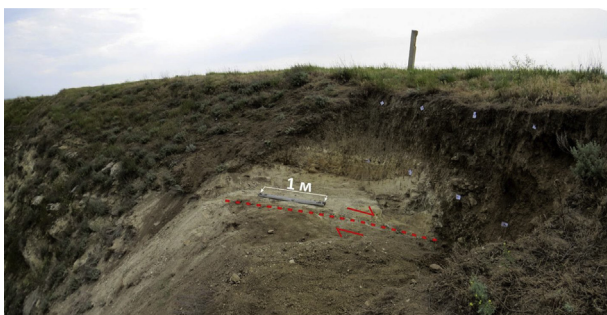
Fig. 9. The on-site photo showing the trench layout in the fault zone east of Kytaiia.

The relationship between the loose sediment layers suggests that the main displacements were horizontal. This is evident from the fact that different facies adjoin each other along the ruptures without significant vertical displacement, but with a pronounced change in thickness. For example, we can see that humus-bearing coarse fragmental deposits, which are typical of the cliff slope, adjoin mature soils with the cultural layer that accumulated on the flat ground a few meters away from the cliff edge. It can be assumed that these sediments were brought together by the displacements of the western wall to the north, i.e., the dextral strike-slip motion (see Fig. 9 for the trench layout).
